Subject: EGR System

**Application: 900 Turbocharged models with EGR
1990–1992**

CATEGORY	
Engine	
SECTION 2	PAGE 24
ISSUE 10/92–0264	CODE 254

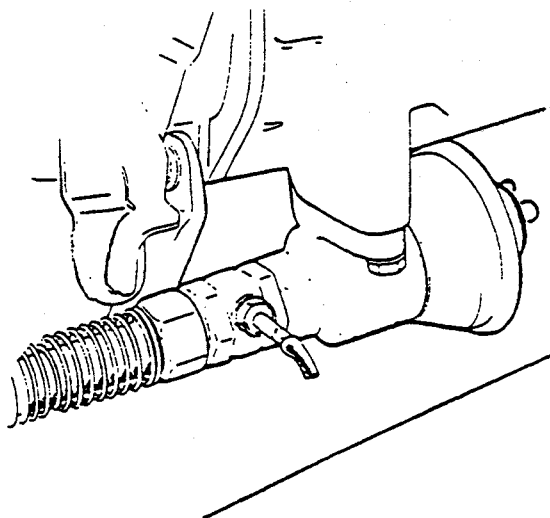
Figure 1. Removing EGR Valve Retaining Bolts

Under certain operating conditions, such as prolonged deceleration, or very light throttle cruise, exhaust gas temperature may drop below the sensor threshold for the On–Board Diagnostic monitoring system. The LH Electronic Control Module (ECM) will then light the MIL, falsely indicating that there is no exhaust gas recirculation (EGR) flow under operating conditions in which there ought to be. Follow the Action below to rectify this complaint.

1. Remove the EGR valve retaining bolts and remove the EGR pipe from the exhaust manifold. Lift out the valve and pipe (figure 1).

Plug the pipe connection in the exhaust manifold by means of threaded plug P/N 81 23 739 and replace the EGR valve with plate P/N 93 58 177, gasket P/N 75 07 973 and two bolts 80 19 887.
