SERVICE INFORMATION

SI No. 410-1976 Date June 1998 900
PI No. 4/98 Grupp 4 D 3.0 Distr. all

Clutch operation complaints

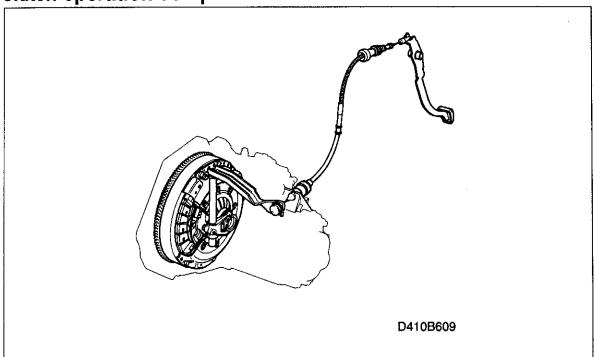
In some cars, the clutch cable may malfunction which results in problems when operating the clutch. A malfunctioning cable may cause customer complaints such as increased clutch pedal effort or improper freeplay. In case of customer complaints, the following should be done.

- 1 Remove the clutch cable, see Service Manual 4:1. Manual transmission, Clutch operation, clutch wire dismantling/assembly.
- 2 Lubricate the clutch cable mountings by the clutch pedal and clutch arm with silicone grease 87 81 718.
 3 Fit the new clutch cable, see 4. Power transmission,
 - Fit the new clutch cable, see 4. Power transmission, Manual gearbox, Clutch cable, Adjustment/replacement.

The adjusting mechanism must be completely pressed in towards the firewall for the adjustment to function. Also note that the locating bracket (figure 4) is critical to the correct adjustment and operation of the clutch and cable.

- 4 Inspect and replace bracket, P/N 44 90 249 and screw, P/N 79 72 805, if damaged. Check that the bracket is centered on the sleeve and that the sleeve is fitted according to the measurement in the illustration. Tighten the bracket to the body.
- 5 Check that there is free play in the clutch pedal.
- 6 Check that the clutch cable follows the upper curve (6A) if the clutch is new. There is a need for some excess, since the cable casing is stretched when the
- pensate for this. When the clutch is worn, the cable will follow the lower curve (6B).Make sure that the clutch cable has a smooth routing
