Subject: Correcting Leakage Around Gear Selector Shaft

Application: 1994- 900 and 9000 Models with Manual Transmission

CATEGORY		Transmission	
SECTION	4	PAGE	26
ISSUE	12/94-0529	CODE	471

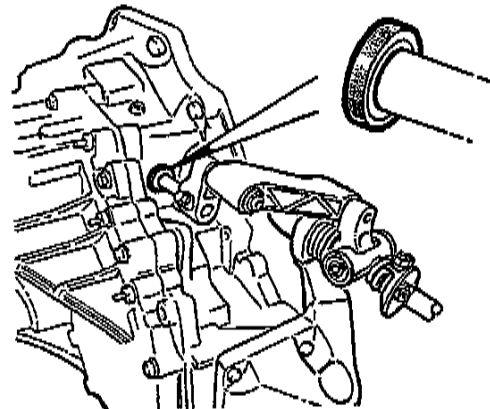
It is possible that on certain 1994 and later 900 and 9000 models equipped with manual transmissions that the seal on the gear selector shaft may leak. This has been remedied in production by fitting an improved seal. To correct an in-use vehicle leak, follow the steps outlined below and on the following page.

Figure 1. Area of leakage around gear selector shaft

- 9000 model: Remove the intake pipe from between the throttle body and the resonator/charge air cooler.
- Clear the area around the gear selector shaft, engage 4th gear and fit locking pin P/N 87 92 335. See Figure 2.A.
- 900 model: Remove engine covers (V6). Undo the M8 bolt on the gear selector shaft and move the gear lever to 3rd. See Figure 2.B.
9000 model: Remove the taper pin using removing tool P/N 87 91 394 and move the gear lever to 3rd. See Figure 2.C.
- Carefully pry out the seal using a thin screwdriver. See Figure 2.D.

- Clean the gear selector shaft and check that there are no sharp burrs.
- Wind thin, smooth tape once around the hole in the gear selector shaft. See Figure 2.E.
- Fill the back side of the seal with grease, lubricating the sealing surface and slide the seal over the gear selector shaft. Remove tape and tap in seal using tools P/N 87 90 685 and P/N 87 91 709. See Figure 2.F.

8. Assemble gear selector shafts using the M8 bolt (900) or the taper pin (9000). See Figure 2.B.
9. Check, using the appropriate service manual, that the gear position is aligned with gear lever. Remove locking pin and fit protective plug. See Figure 2.A.
10. 9000 model: Fit intake pipe between throttle body and resonator/charge air cooler.
