SERVICE INFORMATION

SI No. 210-2418	Date October 2003	9-3 (9400)
PI No.	Distr. all

Oil leakage from engine

Saab 9-3 M99 - M03 with engine variant B205 and B235

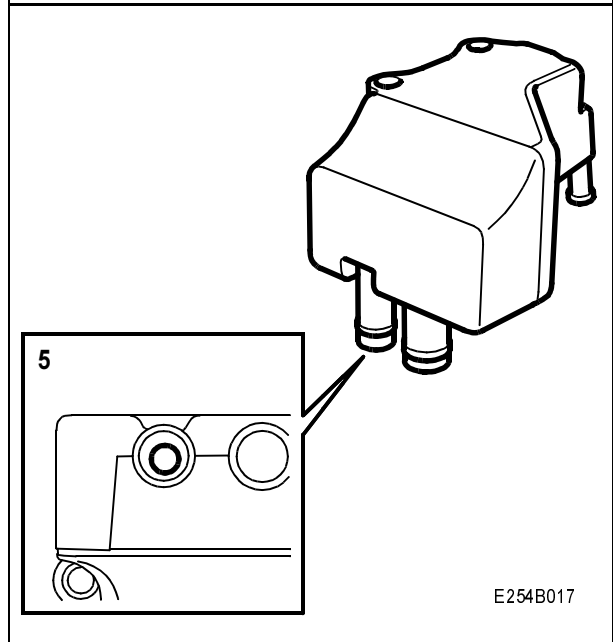
In certain operating conditions the crankcase ventilation throughflow may be inadequate and this can cause oil leakage. Leakage most commonly occurs at the joint between the timing cover, the cylinder block and the cylinder head as well as leakage at the crankshaft seal. Efficient crankcase ventilation is also very important for avoiding increased oil consumption.

- 5 Turn the oil trap as indicated in the illustration and drill the hole with the extra restriction up to 10 mm.
- 6 Blow clean the oil trap thoroughly.
