SERVICE INFORMATION

SI No. 432-2024
 Date November 1998
 900

Improved bush and gear linkage

Saab 900 M94-96 with manual, alternatively Sensonic gearbox

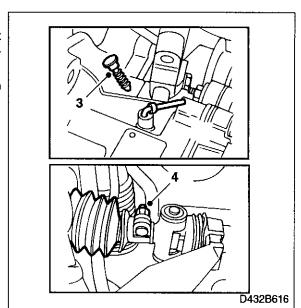
- 5 Move the gear lever to 3rd gear position so that the gear rod slides out of the linkage. Remove the screw securing the linkage to the gearbox.
- 6 Raise the car.
- 7 Remove the gear linkage.
